# THE LEADING EDGE

NEWSLETTER OF MUROC EAA CHAPTER 1000

December 2009

## Shields Up!

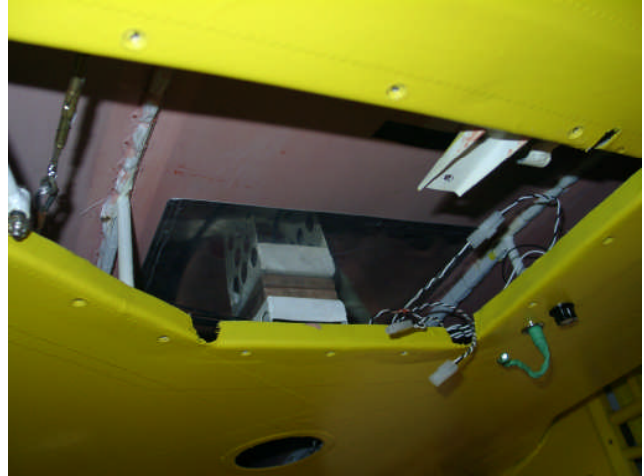
I had not originally installed a ground plane, since **Bob Archer** had told me that the fuselage and wing structure would suffice as a ground plane. Back home again, my avionics guy suggested that I put in an aluminum ground plane at least 12 inches square. Because of the way I had installed access to my trim system, this was actually possible without too much difficulty. I did this, but it had no effect on the problem. Even so, I left the ground plane in place.

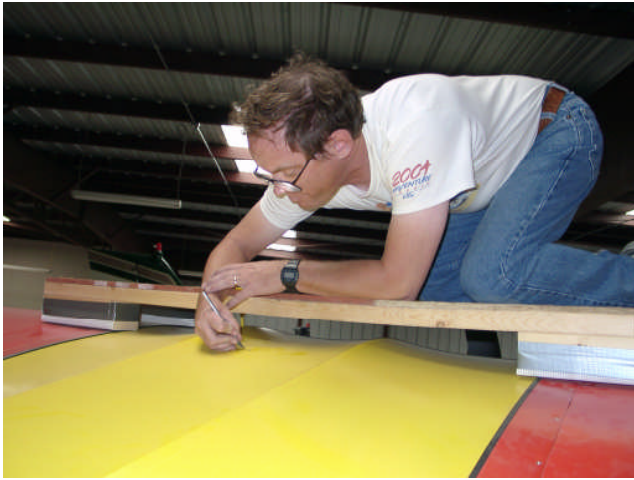
Moving on to the next theory: The antenna lead was connected to the antenna with a crimped ring connector held in place by a nut. The shield was connected to the fuselage structure. The new theory was that the portion of the antenna rod below the ground plane was acting as a low gain antenna, spewing RF down into the cockpit. I thought I could solve this problem by replacing the antenna with a COMANT CI-121 antenna. I had to replace the antenna with something, since it was now too short. Since the COMANT antenna used a BNC connector, I thought this would keep the RF inside the antenna lead shield until it was time to come out the antenna. The new antenna was installed after modifying the antenna mount. This required the construction of what **Stormy** and I called "The Bridge to Nowhere", which was supported on the wing roots and allowed me to work above the fabric covered fuselage.

After completing the installation, a test of the radio and autopilot showed...no change.

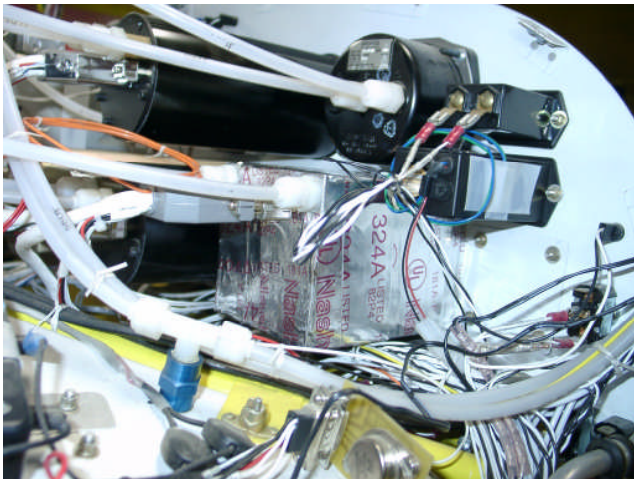
As I said, I'm not a EE, and at this point I wasn't doing a good job of playing one. It seemed that the problem was that antenna 1 was just too close to the autopilot control head. Because of the R-squared rule, the power of the RF reaching the autopilot control head from antenna 2 was one-tenth that from antenna 1, which could explain why one antenna was a problem and the other wasn't. Reviewing the autopilot documentation, TruTrak claimed that the autopilot control head was shielded from any RF interference. There was also a note that the control wheel steering wire might need to be shielded because it was the most vulnerable. I used a handheld radio transmitting right next to this wire and it had no effect. However, the response of the autopilot was very well correlated to the distance between the handheld radio and the autopilot control head. Transmitting the radio right in front of the instrument face had no effect, but anywhere behind the instrument panel (toward the firewall) there was a response to the radio, decreasing with increasing distance from the autopilot control head. More discussions led to the theory that maybe the autopilot control head wasn't shielded as well as TruTrak claimed. It was in a plastic box after all.

After much thought, I decided to cover the box by wrapping the tape in a spiral fashion around the box. If I could completely cover the box with one piece of speed tape, then the entire shield would be electrically connected to itself. When the spiral got to the end of the box, there was just enough extending beyond the box to fold over and cover the back completely. Thus I completed a shield that covered 5 sides (not the display face) completely and was fully connected electrically.

I installed the autopilot control box back in Three Sigma and ran the ground test again. This time transmitting on either radio (both antennas) produced no response from the autopilot. Success!

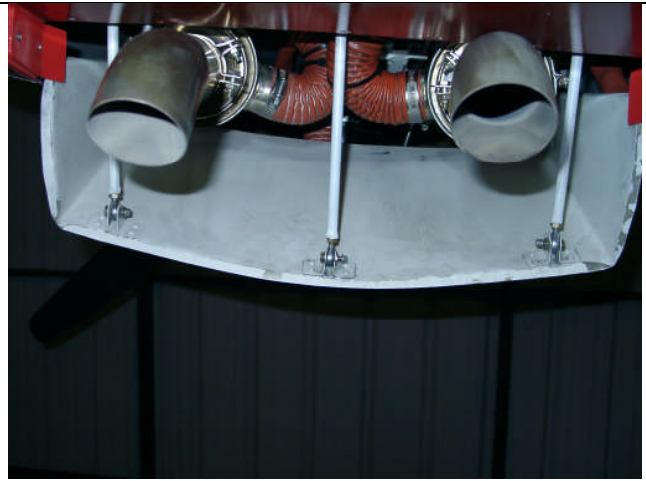
The number one issue of all was the persistent lack of suitable engine cooling. I had determined before going to Oshkosh that I could keep the CHTs more or less under control, though somewhat hotter than desired (generally about 390F to 435F), if I kept the cruise power to less than 65%. Climbing was a bit of a problem, requiring low RPMs and high climb speeds. I also had to reduce RPM upon reaching pattern altitude on the initial climbout.

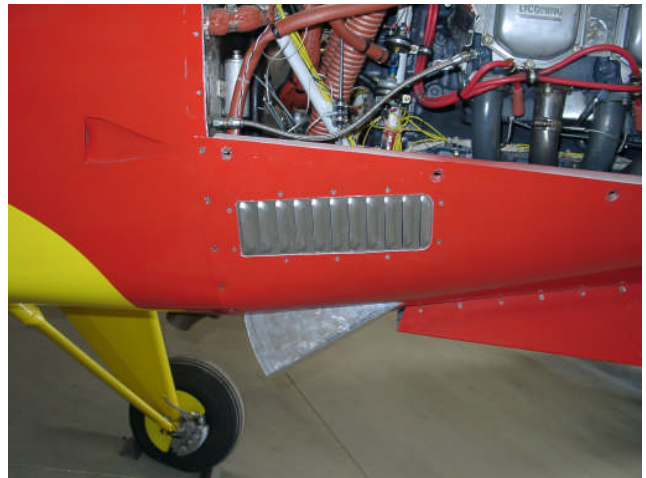
I designed my cowl flap to have an exit area equal to 150% of the intake area, which is a recommended ratio. So why didn't it work? If you look up my cowl flap, what you'll see is a whole mess of exhaust pipes, mufflers, and SCAT tubes that seem to create a lot of blockage, effectively reducing the exit area. My solution was to add louvers to the sides of the cowling, where the cooling air could go straight from the cylinders unencumbered out the side of the cowling. The louvers are Avery part number 4685. Do they make a difference? Who knows? That answer will have to wait until after flight testing. I'll paint the louvers someday after I sort all of this out.

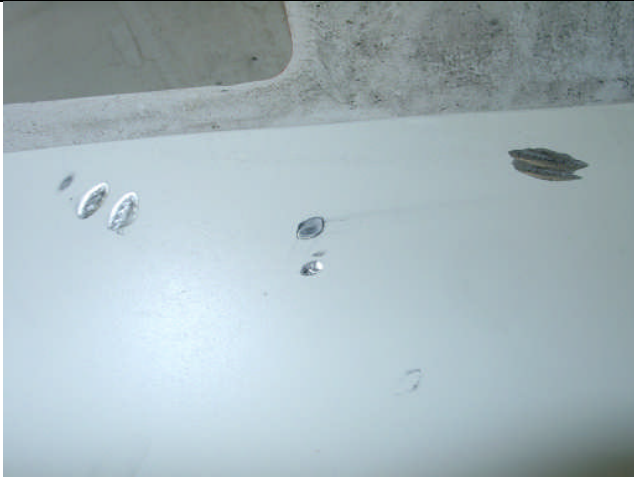
You may have noticed in the photo above that the cowl flap isn't painted anymore. After getting back from Oshkosh I noticed some weird wear marks on the inside of the cowl flap.

If I pushed up on the cowl flap, these marks lined up perfectly with the muffler and SCAT tube clamp. That told me that air pressure was deforming the cowl flap, and the front edge needed stiffening. I was going to rivet an angle to the cowl flap to make a flange. Then I noticed a 3 inch crack next to the right pivot point.

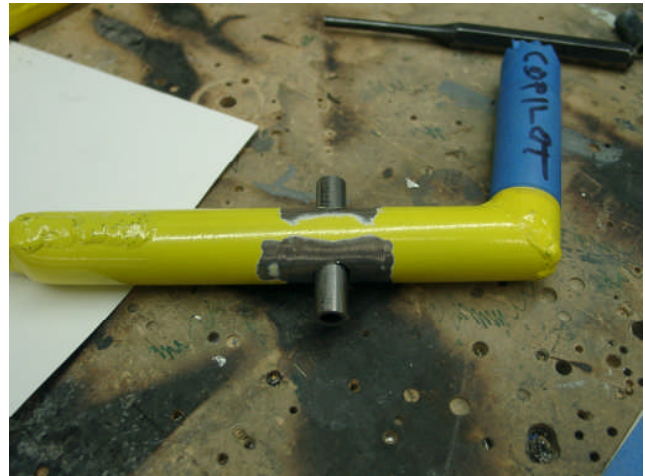
the excessive free play in the pitch stick. The top of the stick could be moved about 1/2 inch without moving the lower part of the control stick assembly. In case you're not sure, that is WAAAAAY too much! This came about because there was way too much clearance between the lateral pivot bolt and the pivot tube in the control stick. How did this happen? The answer to that lies in a dirty little secret of the 4130 tubing world. While the outside dimension of a tube is usually very close to the proper dimension, the inside diameter (wall thickness) is not nearly as precise. The plans call for a 3/8x.058 tube for the pivot tube. I ordered such a tube and used it for the pivot tube. If the tube had been dimensionally correct, there would have been a total of 0.009 clearance with an AN4 (1/4 inch) bolt. I would later estimate that the total clearance between my bolt and pivot tube was something like 0.028. Because I used material from the same tube for both control sticks, both of them had the same excessive freeplay.

To fix the pitch freeplay, I removed the control sticks from the airplane and ground down the welds holding the pivot tubes in. I then punched the old pivot tubes out. Now using a 3/8x.063 tube I welded in new pivot tubes.

The key point was that I started with a tube with an inside diameter too small to fit an AN4 bolt into. After the welding was done, I used a 1/4 inch reamer to enlarge the hole to the proper size. Now the AN4 bolt slides in with a tight but smooth fit, even tighter than specified in the plans. Now the total freeplay (entire control system) at the top of the stick is no more than 1/8 inch, which is much more acceptable.

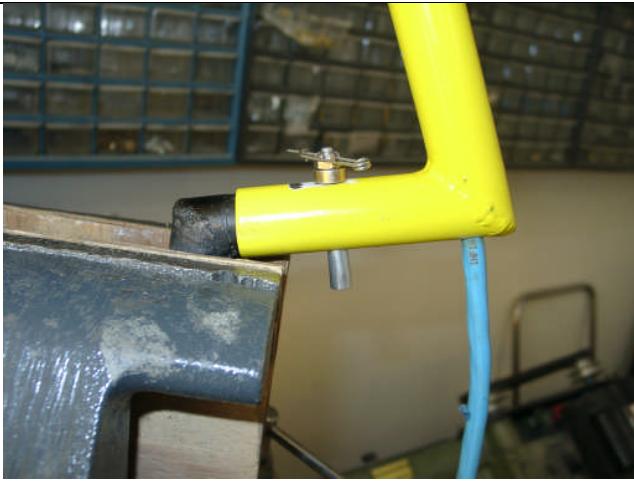
Another freeplay issue was in the lateral stick. The source of this freeplay was the way that I implemented removable control sticks, using a bolt to hold together a tube in a tube. Because of slight clearances around the bolt, the outer tube would rotate around the inner tube slightly. To fix this, I used a B&S taper pin reamer #1 (Aircraft Spruce 12-01622) to open the holes just enough to get full contact of the taper pin (Aircraft Spruce AN386-2-12).

If the hole is reamed too much you won't be able to pull the taper pin in to seat. As you can see in the photo, I could have used a shorter taper pin, but I couldn't tell that before ordering them. With the taper pins in, the two parts of the control stick are locked together as though they were one. Lateral freeplay gone.

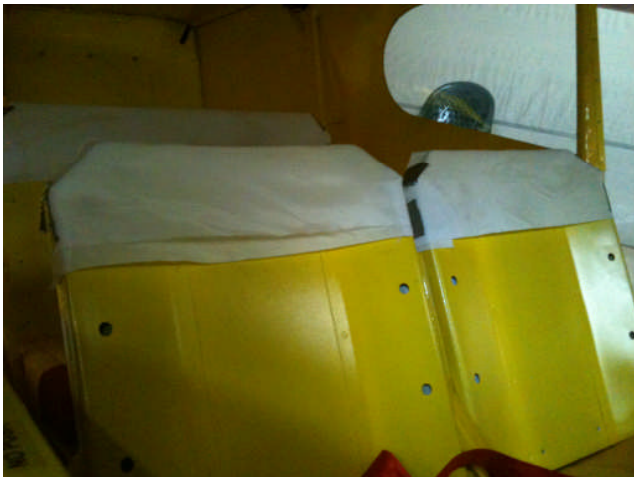
Because of the way I designed my seats, some of the seat structure wore through the fabric of my seat back cushions. I took the cushions back to the lady who sewed them and she repaired them. Based on an idea she had, I used some leftover covering fabric (medium weight Dacron) to wrap around the top of the seat backs. I held it in place with duct tape. The duct tape will probably deteriorate with time, but that's okay because it will be held in place with the cushions and this is a test configuration--I don't know for sure if it will work long term.

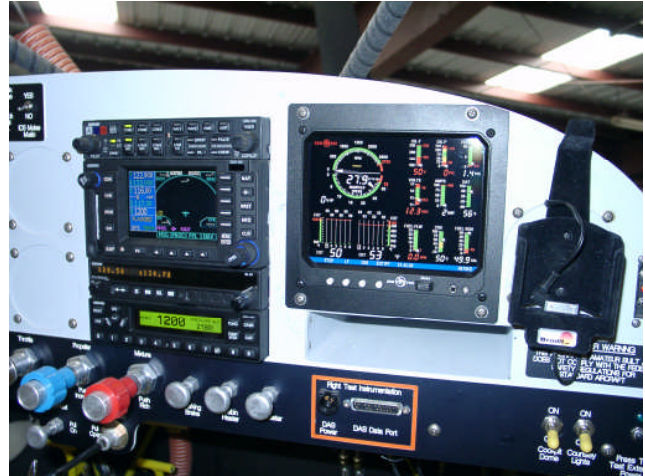
While at Oshkosh I was talking to the JP Instruments folks about a display problem I was having with my EDM-900 engine monitor. They told me I would have to return the display unit to the factory to get it fixed. The next day I went to another JP Instruments booth to ask them a question which to this day I can't remember what it was. While waiting I saw an offer to upgrade an EDM-700 to an EDM-730. This made me think to ask if I could upgrade an EDM-900 to an EDM-930. They said I could for \$800, but I would have to send the display unit in. I already needed to do that anyway, so I decided to do the upgrade. The bad news was that I would have to enlarge the hole in the panel for the EDM-930 to fit. The good news was that

electrically both units use the same circuit board, so the existing wiring harness would plug in with no modifications.

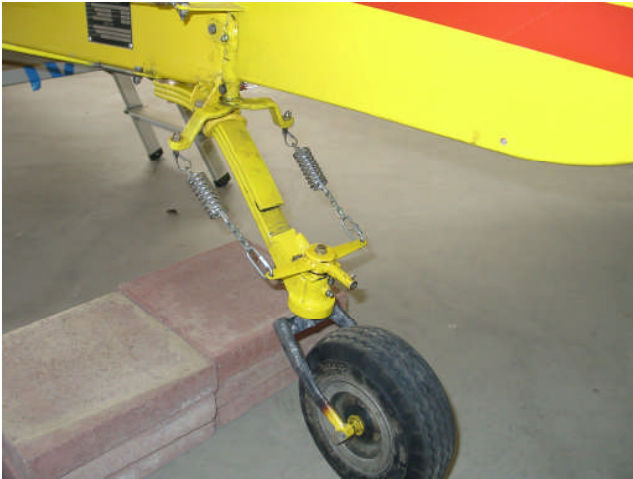
I wasn't too happy with my tailwheel steering as it had a large deadband and wasn't very effective. I had been using the Maule compression springs, where one is a bigger spring than the other. Budd Davisson said that he always used two of the larger springs. I ordered the Aircraft Spruce spring kit (06-15600) which turned out to be two springs of the same size which were larger than either of the springs I had before. I put them on and they seem to be tighter with less deadband. We'll see if it made a difference when I actually taxi.

Finally, at Oshkosh Scott Weinberg strongly encouraged me to reinforce my tailwheel fork. Based on Eric Newton's experiences to and from Oshkosh (breaking the tailwheel fork twice, once on each side) I figured this was probably a good idea. Also shown above you can see the doublers on the sides of the tailwheel yoke. Like the other new parts, I'll paint them after some testing to make sure they don't need more modifications.
