THE LEADING EDGE

NEWSLETTER OF MUROC EAA CHAPTER 1000

August 2011

Chasing Queertrons: Troubleshooting Tales of the Unqualified

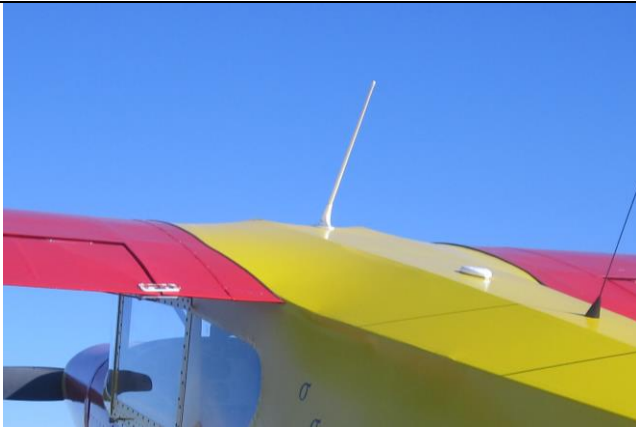
New COMANT antenna installed

(Theory #4). The forward antenna must be too close to the control head, being only about three feet away in a straight line. This is presumably closer than antennas mounted on RVs because the canopy of the RVs forces placement of the antenna farther away or underneath the fuselage on the other side of an aluminum sheet. The aft antenna on the Bearhawk was about 10 feet away from the control head, and according to the one-way R^2 rule the radiated power reaching the control head would be only about 10 percent of that from the forward antenna. That could explain why the aft antenna didn't cause a problem.

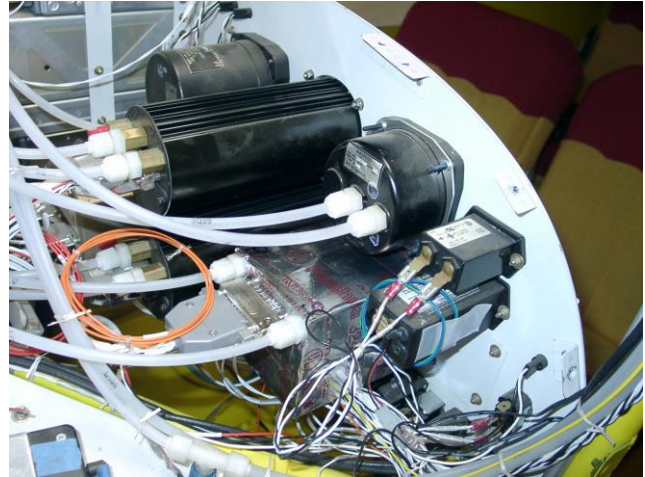
Autopilot control box wrapped in aluminum tape

The box was reinstalled and the ground test repeated. The response of the autopilot to the radio transmission was significantly reduced, enough to be considered effectively zero. Thus, the interference problem was fixed. Yay! There was much rejoicing all around. Flight tests in November 2009 showed that the pitchup with radio transmission was gone.

Based on Theory #4, the solution would seem to involve shielding the control head. Doing some more research on the Interwebs, I found that the theory of shielding was dependent on wrapping a conductor completely around the item to be shielded. If the shield is conductive in a closed loop around the item, the item is shielded. However, if the shield has a break in it, it ceases to be an effective shield. I think of it as the edges act as antennas, re-radiating the RF that the shield is trying to block. That may not be the best explanation, and I invite anyone else to submit a better explanation to this newsletter. To test the shielding idea, I wrapped some aluminum foil around the control head. While not pretty, the ground test indicated that there was a good possibility of this solution actually working.

Complicating the use of this aluminum tape was that the adhesive on it was non-conductive. Thus, to keep the shield conductive without any breaks, the control head would have to be completely wrapped using one continuous strip of tape. In the end, this wasn't that difficult to do. Five sides of the box were covered with the aluminum tape, and the tape was trimmed flush with front of the box where it contacted the instrument panel. (Foreshadowing: The last half of that sentence would prevent this from being a complete solution.) The stickers on the box, such as the serial number and the warranty seal, were covered in plastic to prevent the tape from sticking to the stickers, just in case the tape would have to be removed. Prior to taping, photos were taken of the stickers to retain the information.

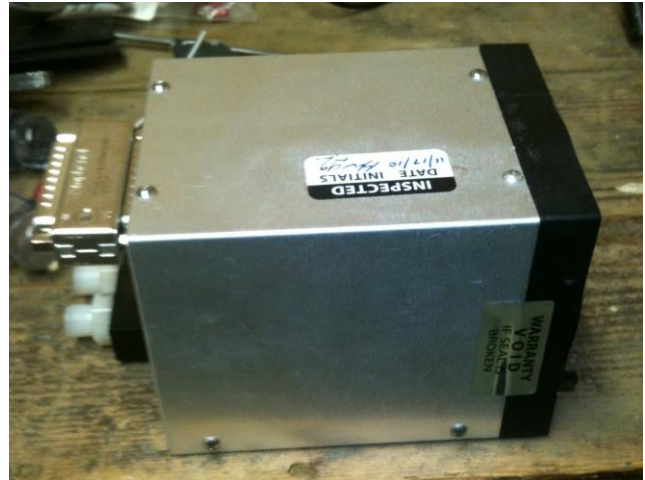
Soon thereafter I removed the control head, removed the aluminum tape, and shipped it back to TruTrak. They made some modifications to one of the circuit boards and completely replaced another circuit board to bring my unit up to the current design. Finally they installed a metal case. They told me that normally they charge \$400 for the service done, but since this was to address a problem that had existed for a long time, they cut me a deal for only \$250. The control head was soon returned and reinstalled. Again, with great hope, I ran the ground test, and...the pitchup remained. Krap! Now what?

New metal case with RF filter connector mounted to DB25 connector

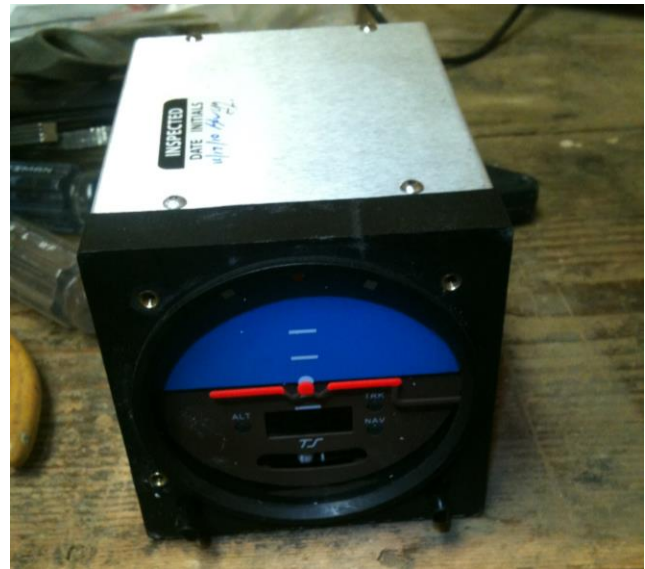
Plastic faceplate which gave an entry path for RF interference

While researching solutions, I came across a roll of copper tape with electrically conductive adhesive (www.amazon.com, part number CFL-5CA/COP07536). I purchased one and used it to wrap the plastic faceplate of the control head. I wrapped from the metal box across the plastic faceplate and around onto the front of the faceplate so that it would contact the instrument panel. The paint was removed from the contact area on the back of the instrument panel. Thus the copper tape with the conductive adhesive formed an electrical connection between the instrument panel and the metal box on the control head, making a complete shield. The control head was reinstalled and the ground test repeated. This time...absolutely no response from the autopilot while transmitting on the radio. Success at last! Subsequent flight testing confirmed that the EMI Dragon had finally been slain!

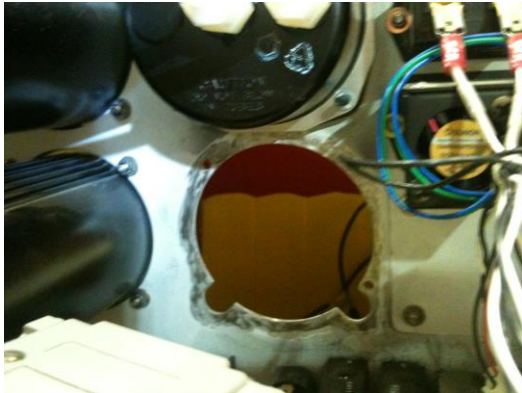
Autopilot mounting hole with non-conductive paint removed

Unfortunately, there were no convenient connectors on the metal box to attach a wire to. The only place I could find to attach a wire was at the DSub connector on the back of the box. I fashioned a ground wire from the DSub connector to a screw on the instrument panel. Running the ground test again showed the same pitchup response as seen without the grounding wire. I described the results to **Randy Kelly** and he said that while the box may be grounded in DC, depending on the length of the wire it may not be grounded in the RF world. I reconfirmed that the short wire I tested before did show a major improvement. I decided I needed to connect as short of a conductor as possible between the metal box and the instrument panel.

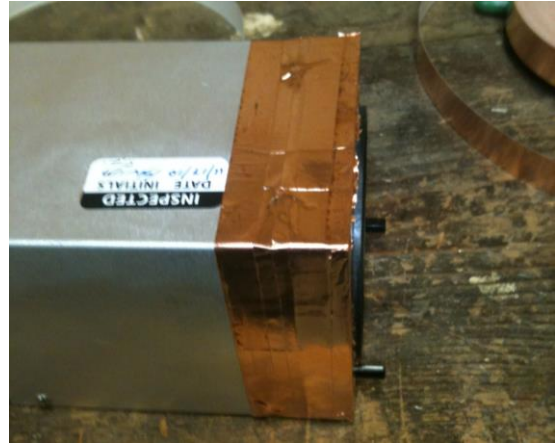
So what happened with the aluminum tape? Why did it work sometimes and not other times? The final answer was a combination of Theories #4 and #6. The control head needed to be shielded, and that shield needed to be electrically connected to the instrument panel. The aluminum tape was trimmed off right at the edge where it would contact the instrument panel. If the aluminum tape happened to be in electrical contact with the instrument panel, the shield worked. However, if vibration or other causes broke that electrical connection, the shield stopped working and the interference problem returned. This would explain how the problem seemed to fix itself in flight--the aluminum tape came back into contact with the instrument panel. Had I thought to wrap the aluminum

Copper tape bridging the gap between the metal case and instrument panel

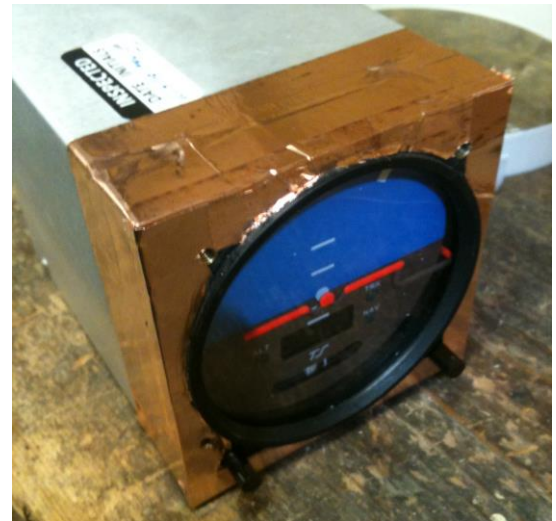
Copper tape wrapped onto front of case to connect with instrument panel

tape around the front of the control head so that it would contact the panel, the aluminum tape would have been the final answer. As it was, the copper tape with the conductive adhesive was a better solution because it was easier to get the required electrical contact.
