THE LEADING EDGE

NEWSLETTER OF MUROC EAA CHAPTER 1000

July 2013

The Joys of Troubleshooting Engine Problems

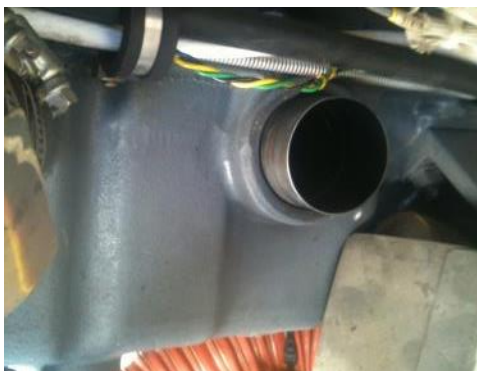
During the condition inspection I had noticed that the intake pipe to #6 cylinder was loose. The connection tube in the oil pan (the one the large rubber hose goes over to connect to the intake pipe) was loose. It is normally swaged with a bead into the oil pan, but for some reason this one had become loose. I had noticed this last year, and just twisted it until it jammed into place. This apparently worked last year, so I tried it again this year.

The loose intake tube in the oil pan

As with so many problems, the actual fix is easy once you figure out what the real problem is. For the loose tube in the oil pan, I had seen this problem before. During the "rebuild" two such tubes had been loose. I had taken them to Bob Browne in Tehachapi who had a magic swaging tool (much like a very large tubing beader) that he used to fix them. Since I didn't want to remove the engine from the airframe, I asked him to let me rent the tool to fix the #6 tube. He agreed, and after removing the lower cowl and the left exhaust system, I was able to re-swage the tube into the oil pan.

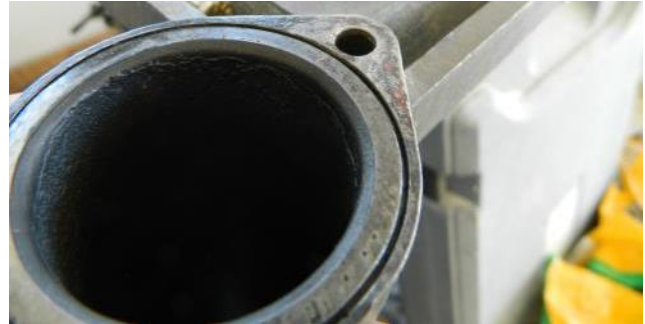
The intake pipe and flange. The surface of the flange and the end of the intake pipe should be in the same plane. They're not—the intake pipe is slightly recessed, maybe about 0.025 inches

When I removed the intake pipe, I noticed that there was fuel residue (with the blue dye) on both sides of the gasket. I reasoned that the intake pipe was not tight against the intake port if there was room for the fuel dye to get on the gasket where it should be compressed between the pipe and port.

All of these things suddenly showed up at the same meeting in my brain, and I posited that perhaps the problem was an **induction air leak**. Not only was this a reasonable cause that I had not considered (a good thing since I had run out of ideas), but it was the first explanation of all those I had tried that could reasonably be traced to being caused by something I had done during the condition inspection. By futzing with the intake pipe I had somehow opened a leak that had not been there before.

The additional air (leakage) in the intake charge caused #6 to run much leaner than intended. At idle RPM, the large difference (vacuum) between manifold pressure and atmospheric pressure drew in a large amount of air through the leaks and leaned the mixture significantly. The high voltage sparks of the electronic ignition were able to ignite this very lean mixture, but it was so lean that it could just barely burn, hence the low EGT and CHT.

As for the top end of the intake pipe, Bob suggested taking the flange that bolts to the cylinder to a disk sander and sanding it down until the recess was the correct depth.

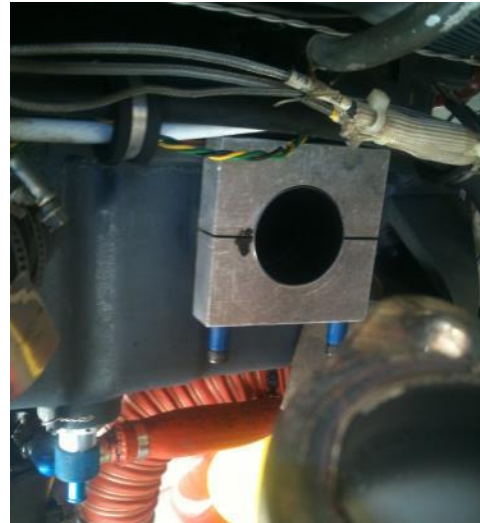
Clamp to hold the tube in place while swaging

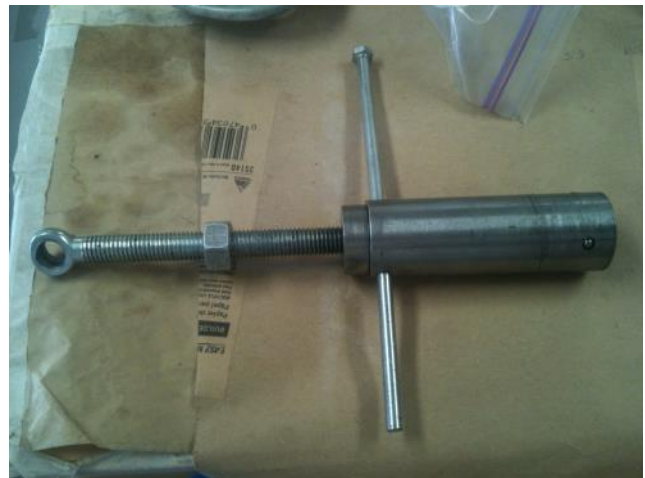
The magic tool. It's like a big tubing beader

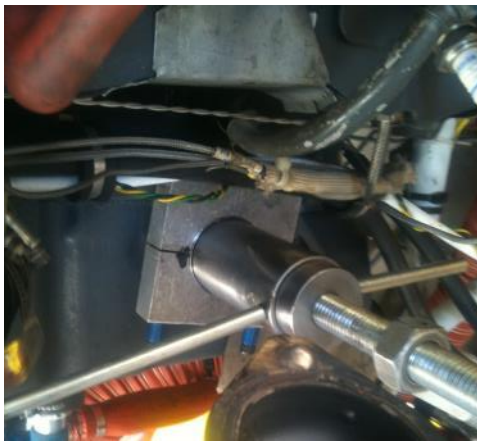
Beading tool inserted into tube

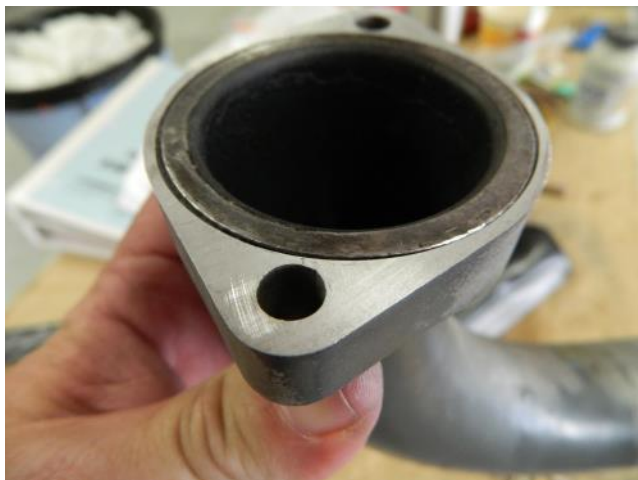
The flange after sanding it down level with the intake pipe

After completing these operations, the intake pipe was reinstalled. Upon starting the engine for the next ground run, I was immediately struck by "Oh that's how smooth the engine used to run!" The #6 EGT was actually the first to come up, and all of the EGTs stabilized at one common value.
