THE LEADING EDGE

NEWSLETTER OF MUROC EAA CHAPTER 1000

July 2008

Return To Flight Program Begets Return To Flight Program

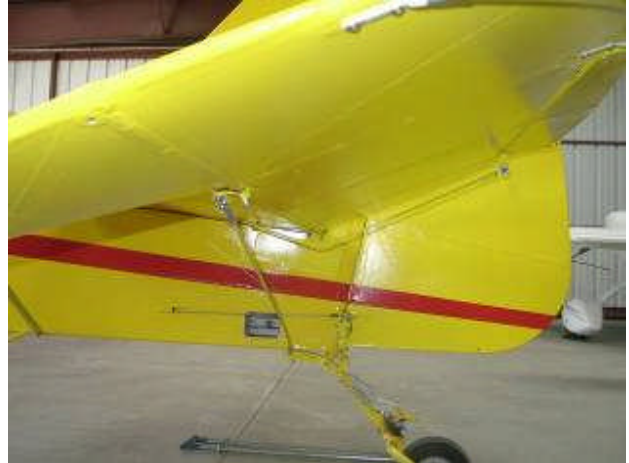
The pushrod conformed to the written parts of the design. While the plans stated that the pushrod had to be bent to clear the elevator hinge line with full up elevator, the amount of said bend was not specified. As seen in this picture, I had bent the rod to be parallel to the surfaces at full up elevator.

The conclusion was that the problem was caused by the excessive bend in the pushrod. The solution was to rebuild the pushrods to conform with a *non-mandatory* engineering notice, which specified using 5/16"x.028

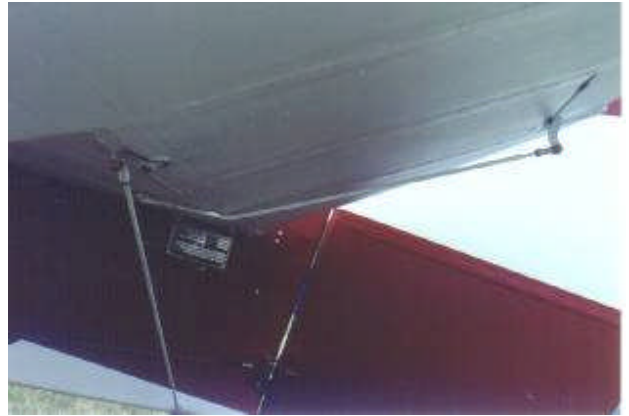
Compare this to a photo of the prototype Bearhawk. On the prototype, the bend in the pushrod is the absolute minimum required, touching the leading edge of the elevator in the full up position.

Discussions with several Bearhawkers, including the designer, revealed that several Bearhawks had flown successfully for many hours with the 1/4"x.035 pushrod originally shown in the plans. However, all of them had only the minimum bend required as shown on the prototype. In fact, **Pat Fagan's Smokey Bearhawk** flew fine with the 1/4" pushrods until the day that **Smokey** made an uncommanded taxi into the hangar door, which increased the bend in the pushrod. Even though Pat straightened the pushrod, the pushrod had been sufficiently weakened that some time after that Pat experienced a similar case in flight of trim tab flutter.

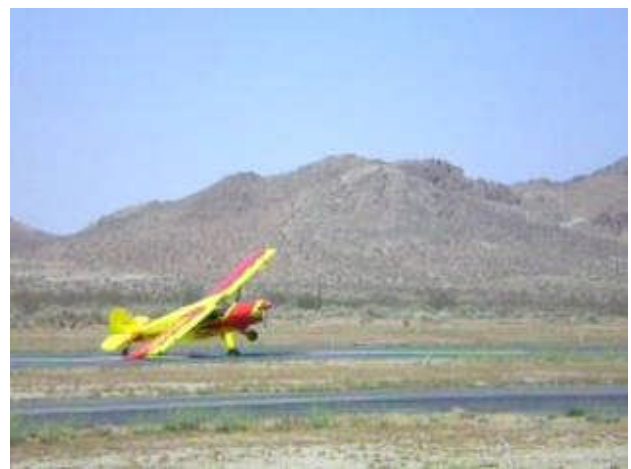
OUCH!

Next I made another classic mistake that I normally watch out for in my glider students. Concerned that I might smack a runway light, I mashed the left rudder to get back on the runway. The problem was I mashed it about two to three times too much. While the remainder of the landing remained on the runway, it was far from straight. In a taildragger, once you start a large deviation, it is very difficult to damp out the oscillation. On this day, I wasn't up to the task. I'm not real sure what happened next, but at some point it became apparent that I was no longer in control. My short personal nightmare came to an end like this:

(BTW, the initial velocity vector was from right to left)

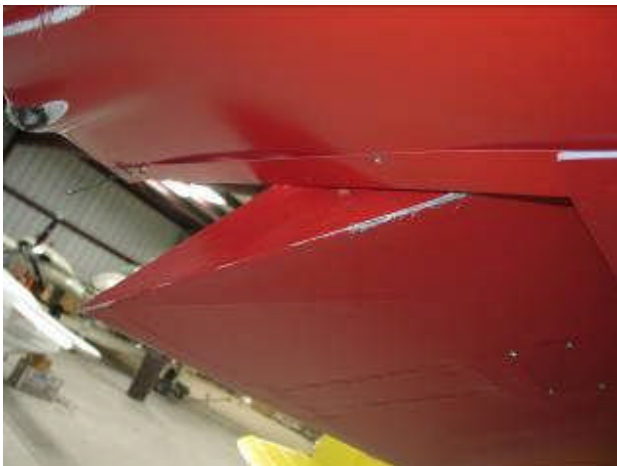
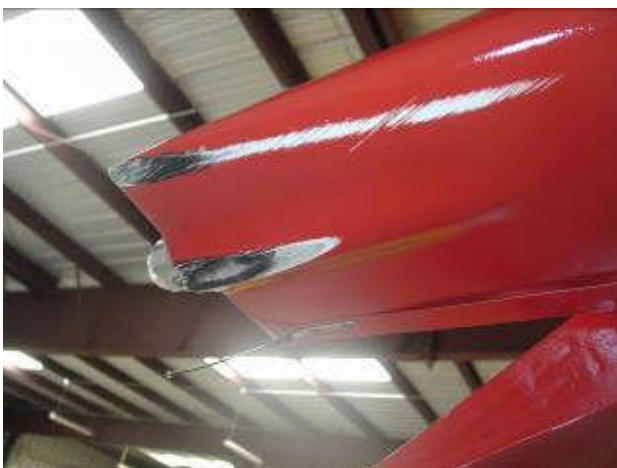
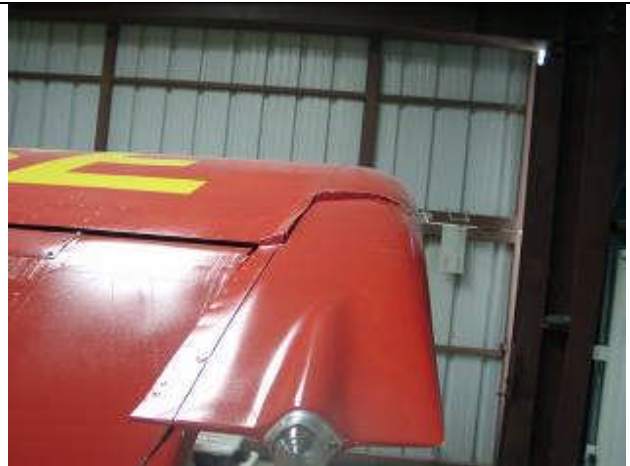
The post-mortem of the wing tip showed noticeable but fairly easily repairable damage. The aileron had no damage to the structure, but needs some fabric tapes added to cover the damage. The sheet metal of the tip rib needs some straightening, which hopefully can be done sufficiently well without having to re-make a bunch of parts. There is also a tear in the tip rib that will need a doubler applied. As for the wingtip, it will need some fiberglass removed, scarfed, and replaced with new fiberglass. Of note is the minimal abrasion on the aft end of the wingtip. **George "Knife" Gennuso** had built up this area heavily with unidirectional fiberglass in anticipation of someone bumping their head into it or backing it into a hangar. We didn't really anticipate this

type of damage, but it seems to have held up well.

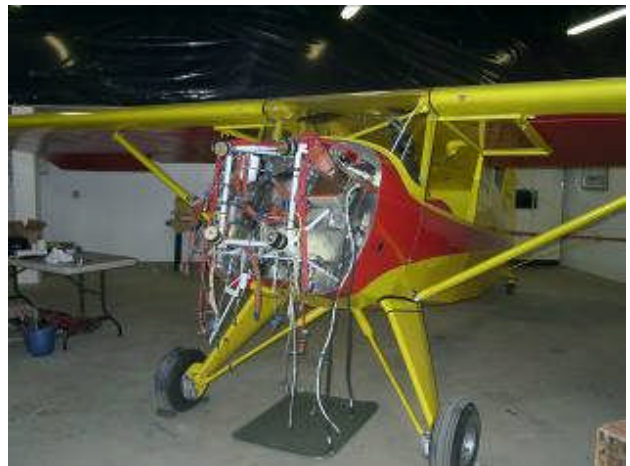
After a few days of work, the nose of Three Sigma looked like this:

After much discussion with local builders and Bearhawkers online, the best solution was still my first response, which was to remove the engine and return it to the guy I bought it from. He told me when I bought it that it came with a one year warranty starting the first time I ran the engine. Now it was time to make a claim on that warranty.
